Problems, Investigation Methods, and Solution of Using String Suspension Insulators

Abstract: - This paper presents the problems, investigation methods, and solution of using suspension string insulators in Thailand. Corona loss, punctured insulator and easy flashover for contaminated insulators are the problems that have existed after using these insulators for a period of time, usually after a few years. These problems incur the reliability degradation of electrical power system. The investigation methods includes; first examination of corona phenomena of the string insulators helps in separating any punctured insulators out of the tested string insulators by observing the corona spots. Second, distributed voltage of the string insulators was checked by using the simple small sphere gaps. Finally, the string insulator characteristics under high humidity were under investigation. We propose the alternating shed long rod insulator prototypes designed and constructed according to IEC to handle the aforementioned problems. The test results are reported in this paper.

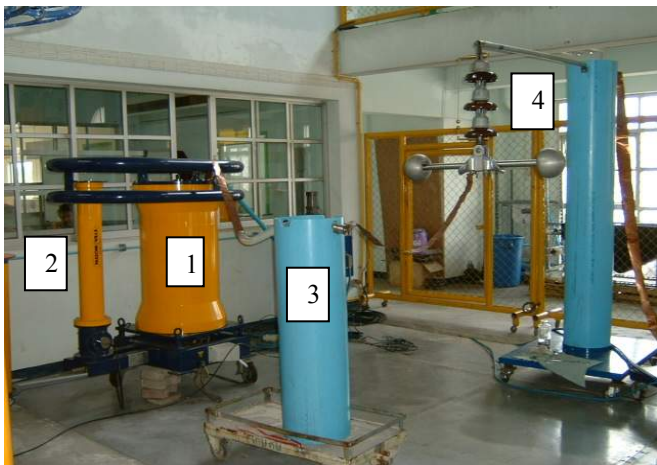
Fig.1. circuit connection arrangements for the experiments

- Where
- 1 = Test Transformer 125 kV, 15 kVA
 - 2 = Capacitor voltage divider 125 kV
 - 3 = Damp resistor 300 k Ω
 - 4 = String insulator (class 52 – 1)

The corona of the proper, improper (punctured), mix proper- improper string insulators were examined using the test circuit shown in figure 1. The punctured voltages of three improper insulators were approximately 13, 14, and 16 kV respectively[8].

The Humidity effect on electrical breakdown of suspension string insulator was examined using the modified test circuit shown in figure 2 in which the string insulator was installed in the test chamber. The fog generator with a controllable steam input

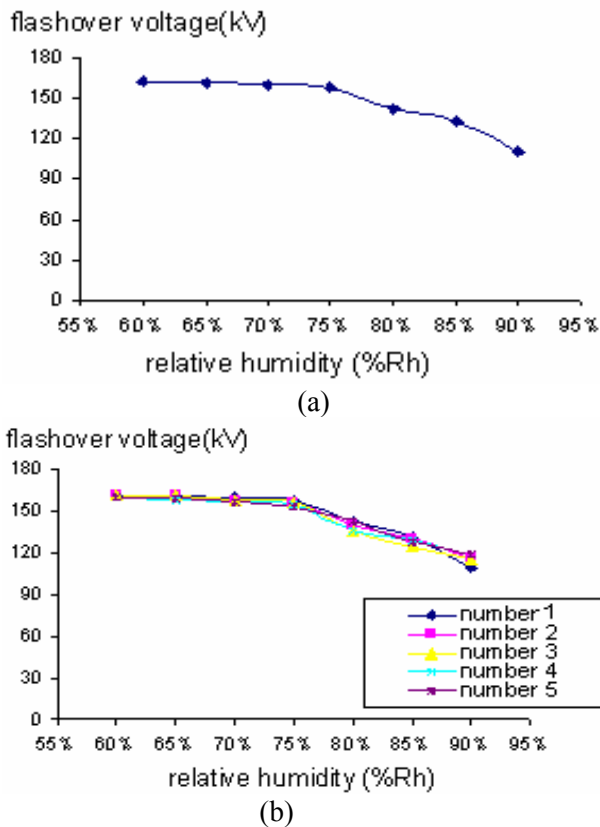
Figure 5. ac power frequency flash over voltage of the string insulator at varied relative humidity levels. (a) string insulator number 1 (b) string insulators number 1-5

From the test results, We conclude that the flash over voltage at power frequency was relatively constant at 60-70 % relative humidity and reduced to 75% at 90 % relative humidity compared with of the initial flashover voltage at 60% relative humidity

rate into the chamber was constructed according to IEC 507[11]. Before testing, the distributed humidity in the testing chamber was checked by 8 humidity sensors. Then the ac voltage of 19 kV was applied to the string insulator about 15 minutes. Next, the steam was fed into the chamber with 50-200 g/hr/m³ until reaching the specified relative humidity. After that, the applied voltage was increased until the flashover occurred. The test results are shown in figure 5.

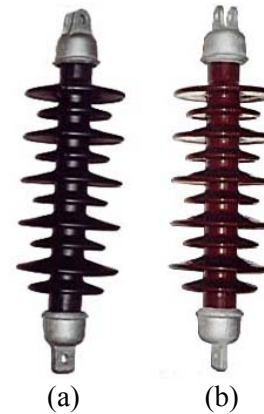
Figure 6. alternating shed long rod insulators (a) ordinary porcelain insulator (b) semi conducting glaze alternating shed porcelain insulator

To solve the problems of using suspension insulator, the 2 types of long rod insulator practically unpuncturable were designed and constructed complying with IEC 815[12]. The designed alternating shed long rod insulators, ordinary porcelain and semi conducting glaze insulators, were tested according to IEC 507[11]. The arcing distance

and leakage distance of the designed long rod insulators are 525 mm and 1370 mm respectively. The experiments were carried out in two parts, flash over voltage test of clean insulator and flash over voltage test of natural polluted insulator after hanging the specimens collecting the pollution at Bang Pu substation 4,8,and 12 month respectively. Bang Pu substation is close to the industrial zone and away from the sea coast about 3 km.

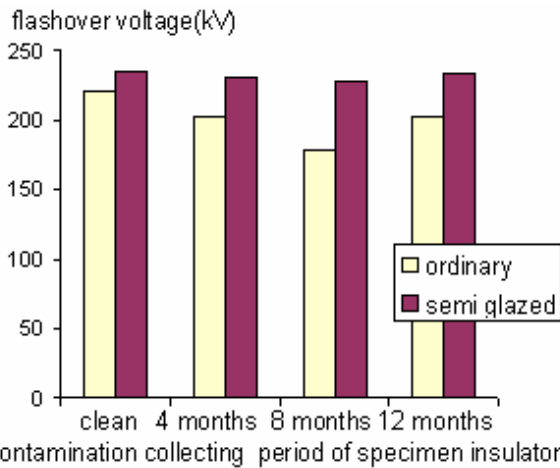
Figure 8. flashover voltages of clean and polluted long rod insulators

The test experiment was carried out according to IEC 507. The ac phase voltage of 19 kV was applied to the sting insulator installed in the test chamber about 15 minutes. Then, the steam was fed into the chamber with 50-200 g/hr/m³ for about another 15 minutes. The applied voltage was increased in the rated of 50 kV/ min until the flashover occurred. The flashover voltage and leakage current were recorded. The test results are shown in figure 8-9 which the dry clean flash over voltage of the specimen insulators in dry condition is approximately the same as that of in clean wet condition [13].

From this experiment we conclude that the semi conducting glaze alternating shed insulator is an alternative choice to solve the problem of punctured in insulators, especially using in contaminated areas because of its benefits in no dry band occurring and being type A insulator.

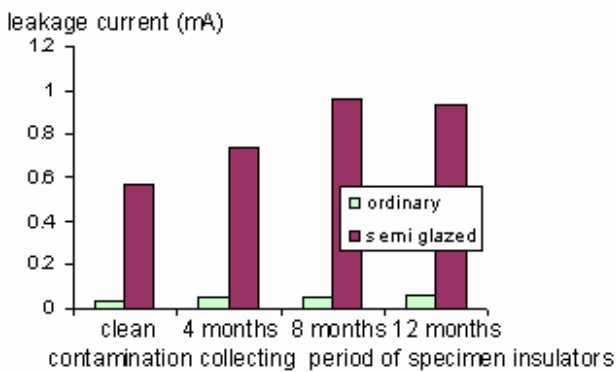
Figure 9 leakage current of clean and polluted long rod insulators at 30 kV applied voltage
