## Post event analysis of the flash flood in small basin

*Abstract:* - Flash floods are one of the major natural hazards occurring on small streams with negative effect on the country as well as on human lives. Flash floods are mostly local events scattered in time and space. Nevertheless, this type of flood, often affecting ungaged watersheds, remains a poorly documented phenomenon. This paper presents a reconstruction of the catastrophic floods occurred in July 2014 which occurred on the Varinka stream in the Vratna Valley and in Terchova village located at the Mala Fatra National Park, Slovakia. The methodology is based on description of past events from 1941 to 2014. These measurements were focused on documenting of the flood development and on measuring of the flood culmination. Subsequently, the measured results were preliminary evaluated. At the end of this paper, there are described some extreme flash floods which occurred on the Slovak territory. The flash flood on July 2014 on the Varinka stream is there compared with the most extreme flash flood occurred on the Mala Svinka stream in July 1998.

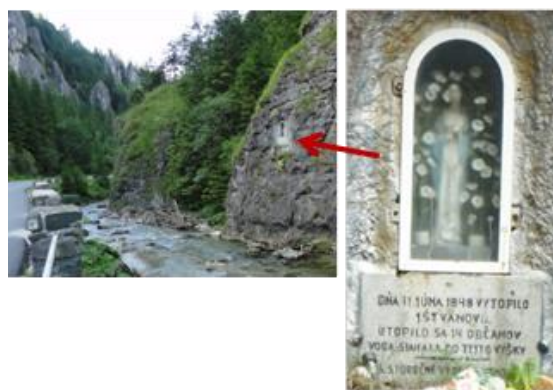
Fig. 2 Detail of the flood mark indicates water level in 1848 (Photos by Pekarova).

The most interesting and the most valuable information about the catastrophic flash flood of 1848 originates from village Terchova on the Varinka / Vratnanka stream. The information was sculpted into the rock in the valley Tiesnavy in year 1848 by woodsman Ferenz Blaha. In the post - war period, around 1948, was the original table rebuilt to place where it stands today. This mark informs that 14 people died on June 11, 1848 in village Stefanova during the flood on Varinka stream, and it shows the water level of the flood (Fig. 2).

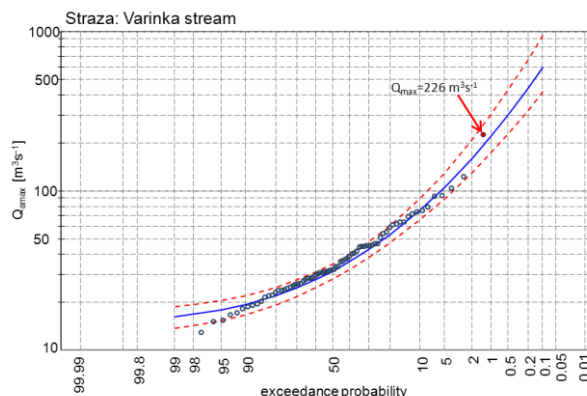
Fig 4 Theoretical exceedance probability curve of annual extreme peak discharges (Log-Pearson, type III.) of the Varinka stream (period: 1941–2014,  $Q_{(5)}$  and  $Q_{(95)}$  – confidence limits).

Table 1 presents the basic geographical and runoff characteristics of the Varinka stream at Straza and in the Tiesnavy gorge. The most extreme discharge on the Varinka stream in the Vratna Valley occurred in 1958 ([24] and [25]). All the upper basin of the Vah River was flooded in that year. The peak discharge on the Varinka stream reached value of 226 m<sup>3</sup> s<sup>-1</sup> ( $q_{max} = 1.62 \text{ m}^3 \text{ s}^{-1} \text{ km}^{-2}$ ) at Straza. Fig. 3 presents the extreme annual discharges which occurred on the Varinka stream at Straza gauge station (basin area 139 km<sup>2</sup>) during the period of 1941–2014. Fig. 4 presents the annual peak discharges exceedance probability curve (Log-Pearson, type III). We included here also the peak of the June 2014 flood. From this curve, *T*-year values were derived for the Varinka stream (Tab. 2).

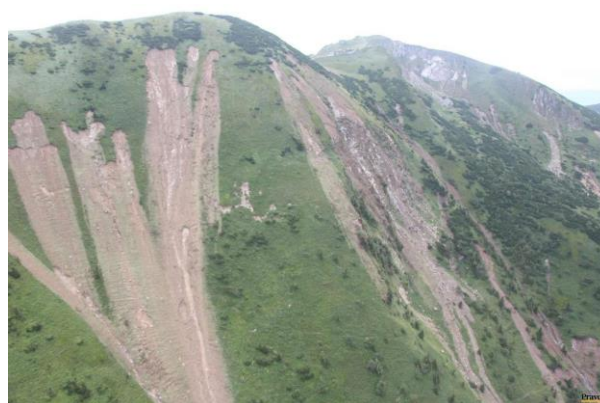
Fig. 5 Landslides in the area of Hromove and Steny in the headwaters of the Varinka stream. (Photo Pekarova).

In contrast to regional floods from year 2010, which were caused by several days of heavy rains on the large area, floods of July 21, 2014 had the character of flash floods. The flash flood in the Vratna Valley was created as result of heavy rainfall on July 21, 2014 and landslides in the area of Hromove and Steny in the headwater of the Varinka stream (Fig. 5).

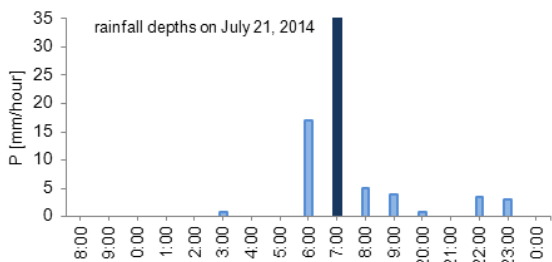
Fig. 6 a) Hourly rainfall depths in the Vratna Valley (at Stefanova station) on July 21, 2014 (Central European Summer Time CEST) and b) Daily rainfall depths in the Vratna Valley (at Stefanova station) on July 2014.

The rainfall on July 21, 2014 was characterized by extreme intensity and extreme rainfall total depth for a very short time. Assessment of the meteorological situation in this northwest area of Slovakia was described in [26]. According to data from the Slovak Hydrometeorological Institute (SHMI), the maximum hourly total rainfall depth reached value of 37 mm in the afternoon on July 21, 2014 at the Vratna Valley (Fig. 6 a) (near the mountain rescue cottage), value of 46 mm in Lubochna village and value of 48 mm at Zilina. SHMI rain gauge station is located in the valley near Stefanova at altitude of 632 m. Maximum precipitation depth per 24 hours in the Vratna Valley (at Stefanova station) was about 66 mm (Fig. 6 b). In the area of maximum intensity of precipitation, directly in Vratna Valley, there is situated no rain gauging station. In calculating the average rainfall for the basin Varinka to Terchova, we additionally took into account the high altitudes in the basin area and the fact that due to rising-altitudes the rainfall totals generally grow (an average of 5 to 10% per 100 meters of altitude). On the windward side of the mountain Hromove in altitude of 1450 m the rainfall might reach 100 mm. The Slovak Hydrometeorological Institute estimated maximum rainfall depths based on measurements of meteorological radars, as well. According to the maximum radar reflectivity, SHMI estimated the

extreme rainfall intensity of 90 mm per 105 minutes (1 hour and 40 minutes) [26]. These rainfall depths would be above average even if they fell per 24 hours.

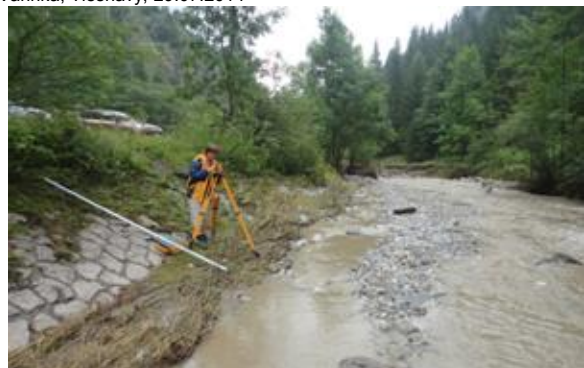
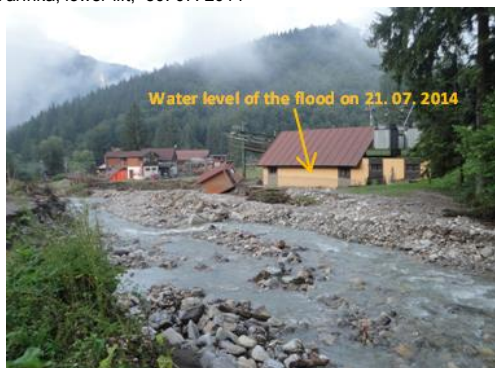
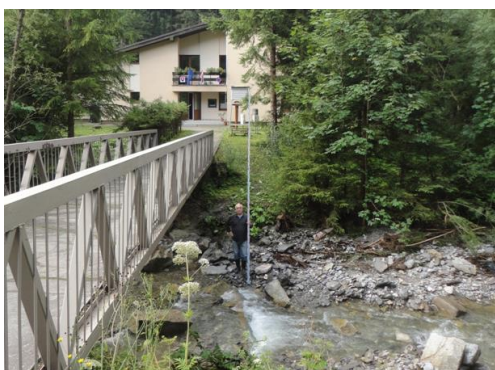
Varinka, Tiesnavy, 29.07.2014

Fig. 7. a-c) Fixation of the cross sections on the Varinka and Stohovy streams according to flood tracks of the flood on July 21, 2014.

As a first step of the reconstruction of the flood on the Varinka stream experimental measurements and photo documentation were done. During the days of July 29, 2014 and July 30, 2014 we measured characteristics of stream needed to calculate culmination (peak) discharges at three profiles:

- a) on the Varinka stream in Tiesnavy gorge (Fig. 7a);
  - b) on the Varinka stream at lower lift station (Fig. 7b);
  - c) on the Stohovy stream near the mountain rescue cottage and rain gauge station in Stefanova (Fig. 7c).
- Subsequently specific yield was calculated according to the defined regional relations of the Sectorial Technical Norm of the Ministry of Environment OTN ŽP 3112-1:03.

According to measurements after the flash flood on Varinka in the Vratna Valley, the peak discharge reached at least value of  $56 \text{ m}^3 \cdot \text{s}^{-1}$  and specific yield reached value of  $2 \text{ m}^3 \cdot \text{s}^{-1} \cdot \text{km}^{-2}$  (on the Varinka stream in Tiesnavy gorge, basin area is  $28.05 \text{ km}^2$ ). Peak discharge reached value of  $57 \text{ m}^3 \cdot \text{s}^{-1}$  and specific yield reached value of  $4.4 \text{ m}^3 \cdot \text{s}^{-1} \cdot \text{km}^{-2}$  (with respect to smaller basin area) on the Varinka stream at lower lift station. Peak discharge reached value of  $6.7 \text{ m}^3 \cdot \text{s}^{-1}$  on the Stohovy stream. Peak discharge reached value of  $63.40 \text{ m}^3 \cdot \text{s}^{-1}$  ( $H=141 \text{ cm}$ , 18:30 CEST and basin area  $139 \text{ km}^2$ ) at Straza gauge station. It corresponds to discharge with return period of 12 years.

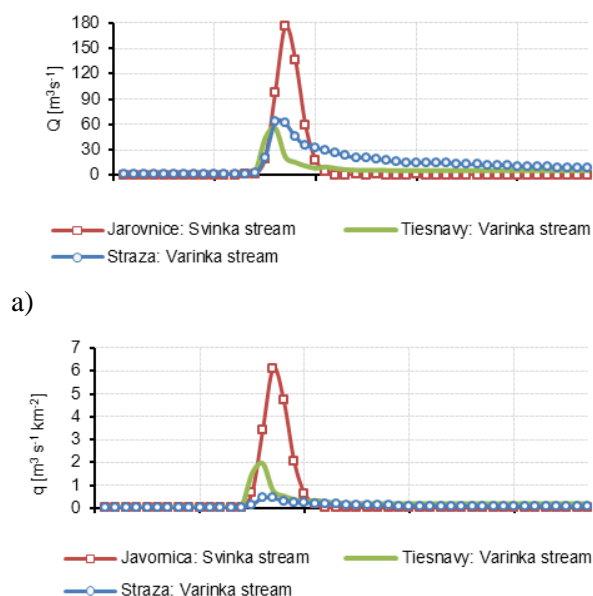
Fig. 9 Hourly flows during the extreme flash floods on the Svinka stream at Jarovnice (July 1998) and on the Varinka stream at Straza (July 2014). Line without points represents estimated flood wave on the Varinka stream at Tiesnavy in 2014 (a) flow [ $\text{m}^3 \text{ s}^{-1}$ ] and b) specific yield [ $\text{m}^3 \text{ s}^{-1} \text{ km}^{-2}$ ].
